## **Technical Memorandum**

### **Surface Impoundment Cap Evaluation for Erosion**

**Gulfco Marine Maintenance Superfund Site  
906 Marlin Avenue  
Freeport, Brazoria County, Texas  
EPA Identification No. TXD0055144539**

December 2010  
EA Project No. 14342.67

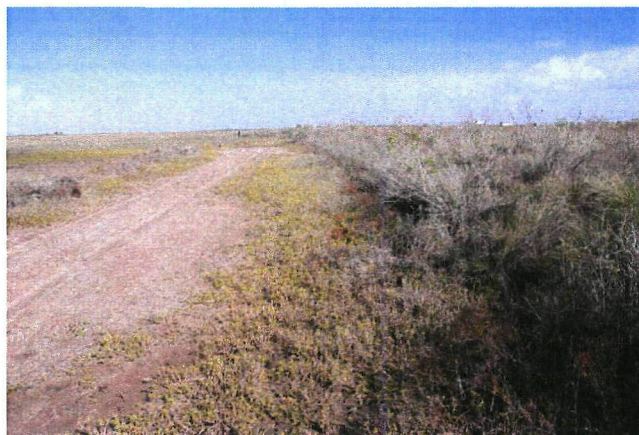
The elevation of the surface impoundment cap is approximately 2 feet higher than the surrounding existing natural surface grade. The existing cap is approximately 2.5 to 3.5 feet thick. The clay cap appeared to be in good condition with no surface cracking during the site investigation. The photo below shows the typical elevation differences between the cap (photo right) and the surrounding areas (photo left).

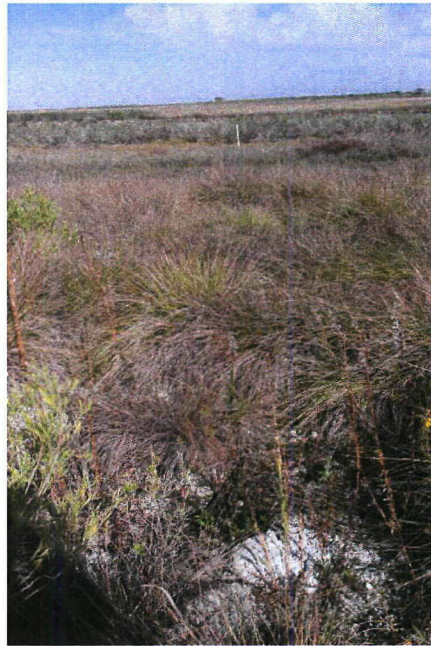
The surface of the clay cap is covered with a layer of oyster shells and vegetation. Cap vegetation consists of mostly grasses with some brush. The majority of the brush is located along the perimeter of the cap with isolated patches within the interior portions of the cap. The photo below shows typical cap vegetation.

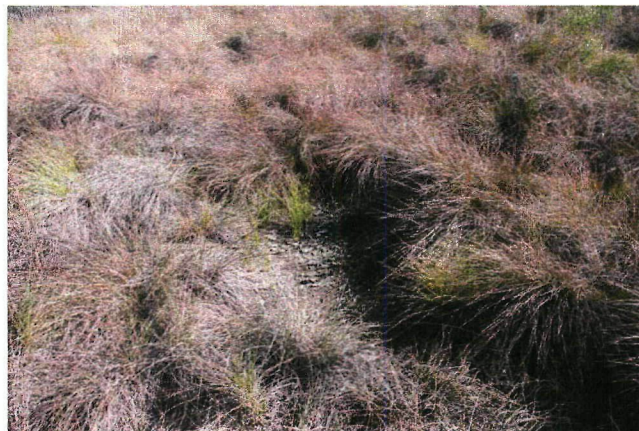
Evidence of vehicular traffic along the perimeter of the cap was observed during the site investigation. Wheel tracks have formed ruts in portions of the vegetation along the western side of the cap. The rutting was generally no more than 3 inches deep with one location found to be approximately 6 inches deep. The photo below is an example of typical vehicle paths through the ground cover.

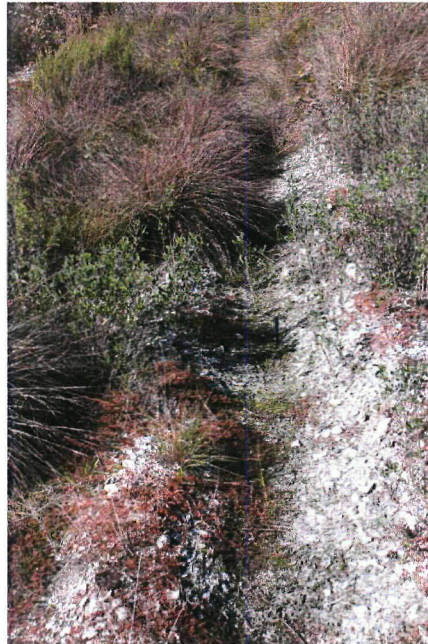
The photo below details the area of deepest rutting (approximately 6-inches).
